DEPARTMENT OF TRANSPORTATION

Contract #: 04-0120F4Cty: SF/ALA Rte: 80 PM: 13.2/13.9File #: 99.28**WELDING INSPECTION REPORT****Resident Engineer:** Siegenthaler, Peter**Address:** 333 Burma Road**City:** Oakland, CA 94607**Report No:** WIR-021440**Date Inspected:** 01-Mar-2011**Project Name:** SAS Superstructure**OSM Arrival Time:** 700**Prime Contractor:** American Bridge/Fluor Enterprises, a JV**OSM Departure Time:** 1900**Contractor:** Zhenhua Port Machinery Company, Ltd (ZPMC) Chanxing Island**Location:** Shanghai, China**CWI Name:** Mr. Qui Wen**CWI Present:** Yes No**Inspected CWI report:** Yes No N/A**Rod Oven in Use:** Yes No N/A**Electrode to specification:** Yes No N/A**Weld Procedures Followed:** Yes No N/A**Qualified Welders:** Yes No N/A**Verified Joint Fit-up:** Yes No N/A**Approved Drawings:** Yes No N/A**Approved WPS:** Yes No N/A**Delayed / Cancelled:** Yes No N/A**Bridge No:** 34-0006**Component:** OBG Segment**Summary of Items Observed:**

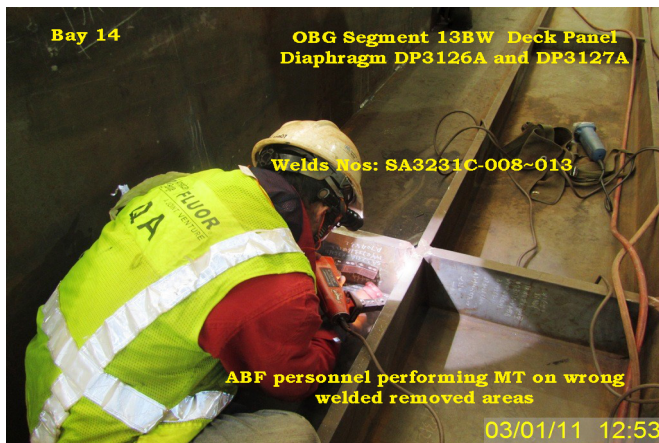
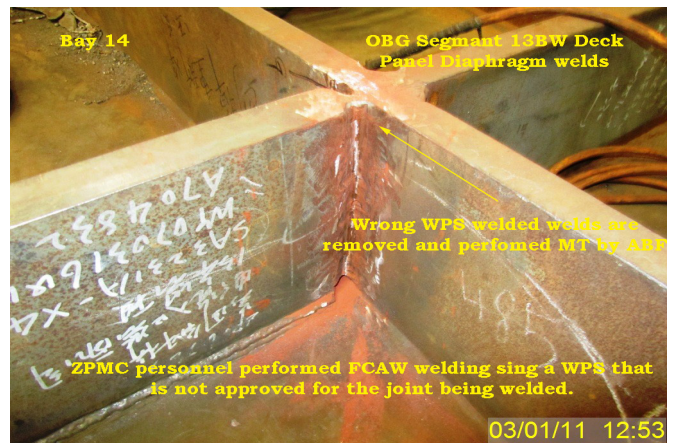
(DP) Sub assemblies DP3126A and DP3127A, this Caltrans Quality Assurance (QA) Inspector witness and observed that ZPMC personnel removed the wrong welded welds and ABF personnel performed MT on these weld removal areas. Regarding this issues CT QA B299 wrote incident report following as:

ZPMC welding personnel performed Flux Cored Arc Welding (FCAW) using a WPS that is not approved for the joint being welded.

-The welding was being performed to WPS-B-T-2133-ESAB which specifies A709-345 to A709-345 material using filler metal brand ESAB Dual Shield 70 Ultra Plus with classification E71T-1M/T-9M.

-The material being welded was A709-345 to A709-HPS-485.

-The welds are fillet weld T-joints, joining Seismic Performance Critical Material (SPCM) diaphragms identified as X4095B and X7516D to Rib Stiffeners identified as RS3387L, M and K.

-The weld joints are identified as SA3231C-008~013. The segment and Panel Point is 13 BW and PP120.5.

- The thickness of the material is 30mm. OBG DP3126A and DP3127A is located in Assembly Bay #14. See the attached pictures.
